Photos of Road Conditions Near Crash Site on Shoreline Highway

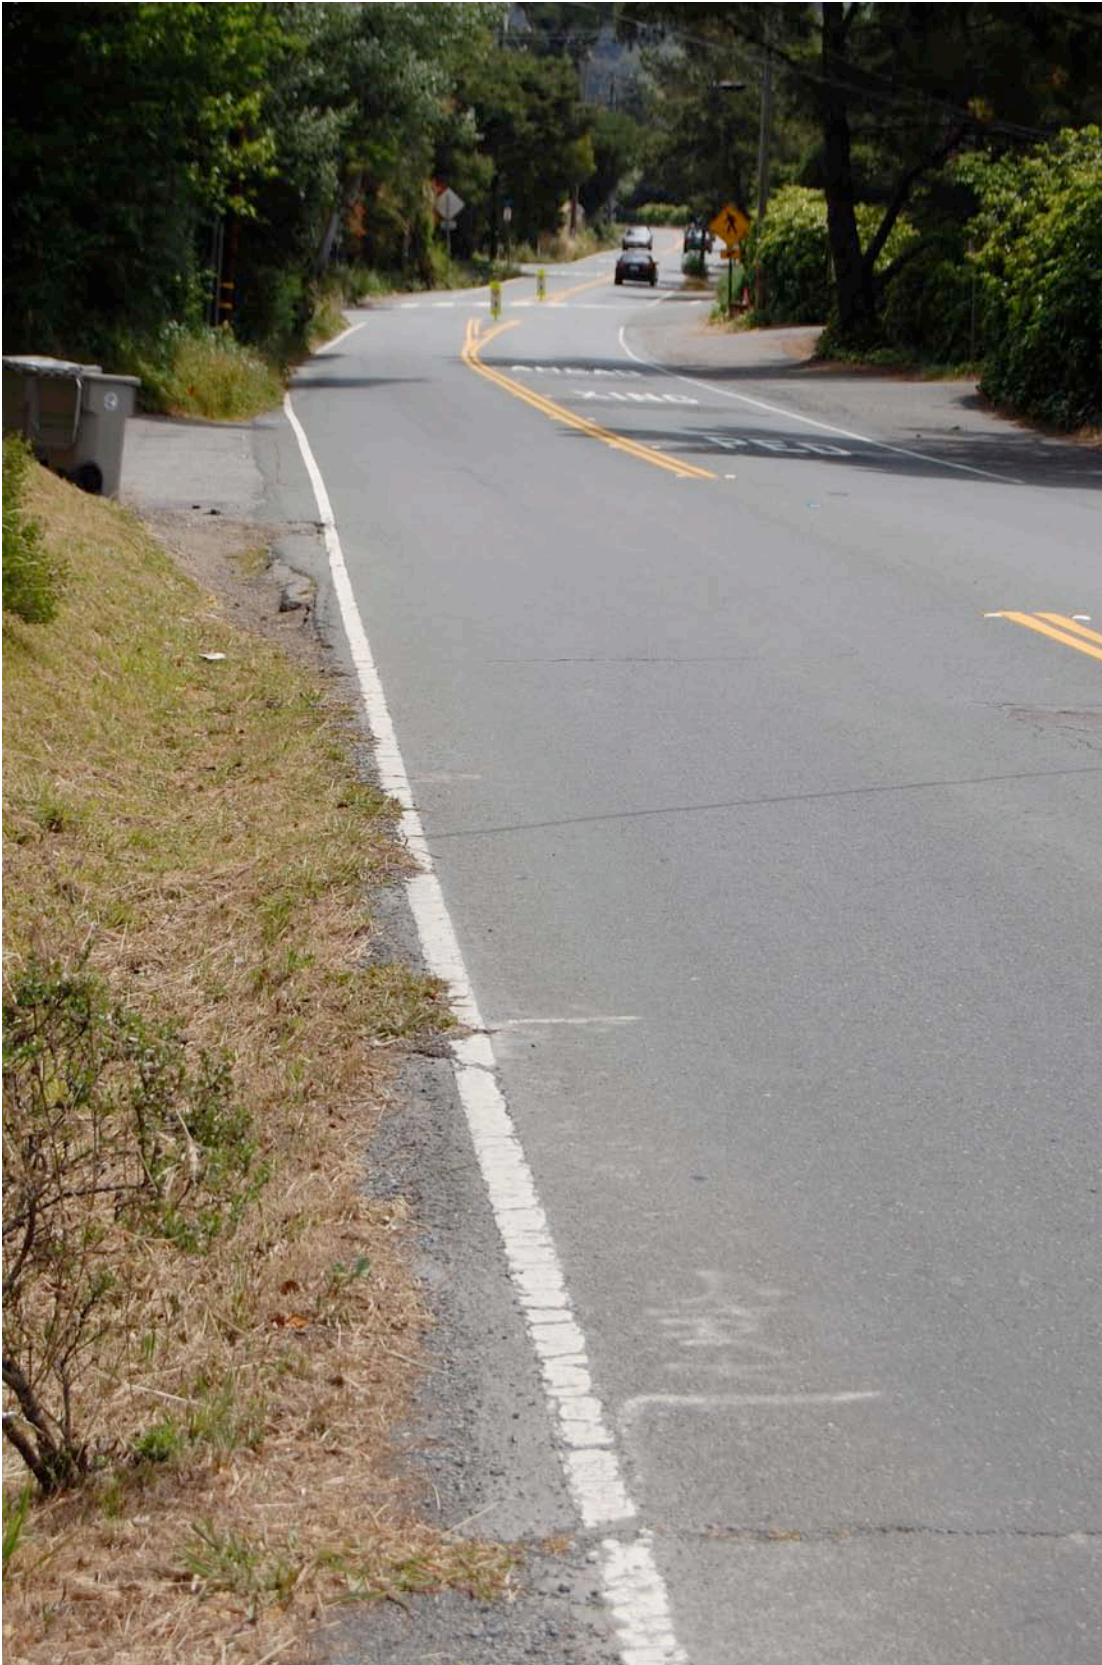
Disappearing fog lines, cracked pavement, and lack of shoulder characterize much of Shoreline Highway in the westbound direction. Note wider shoulder on the other side of the road.

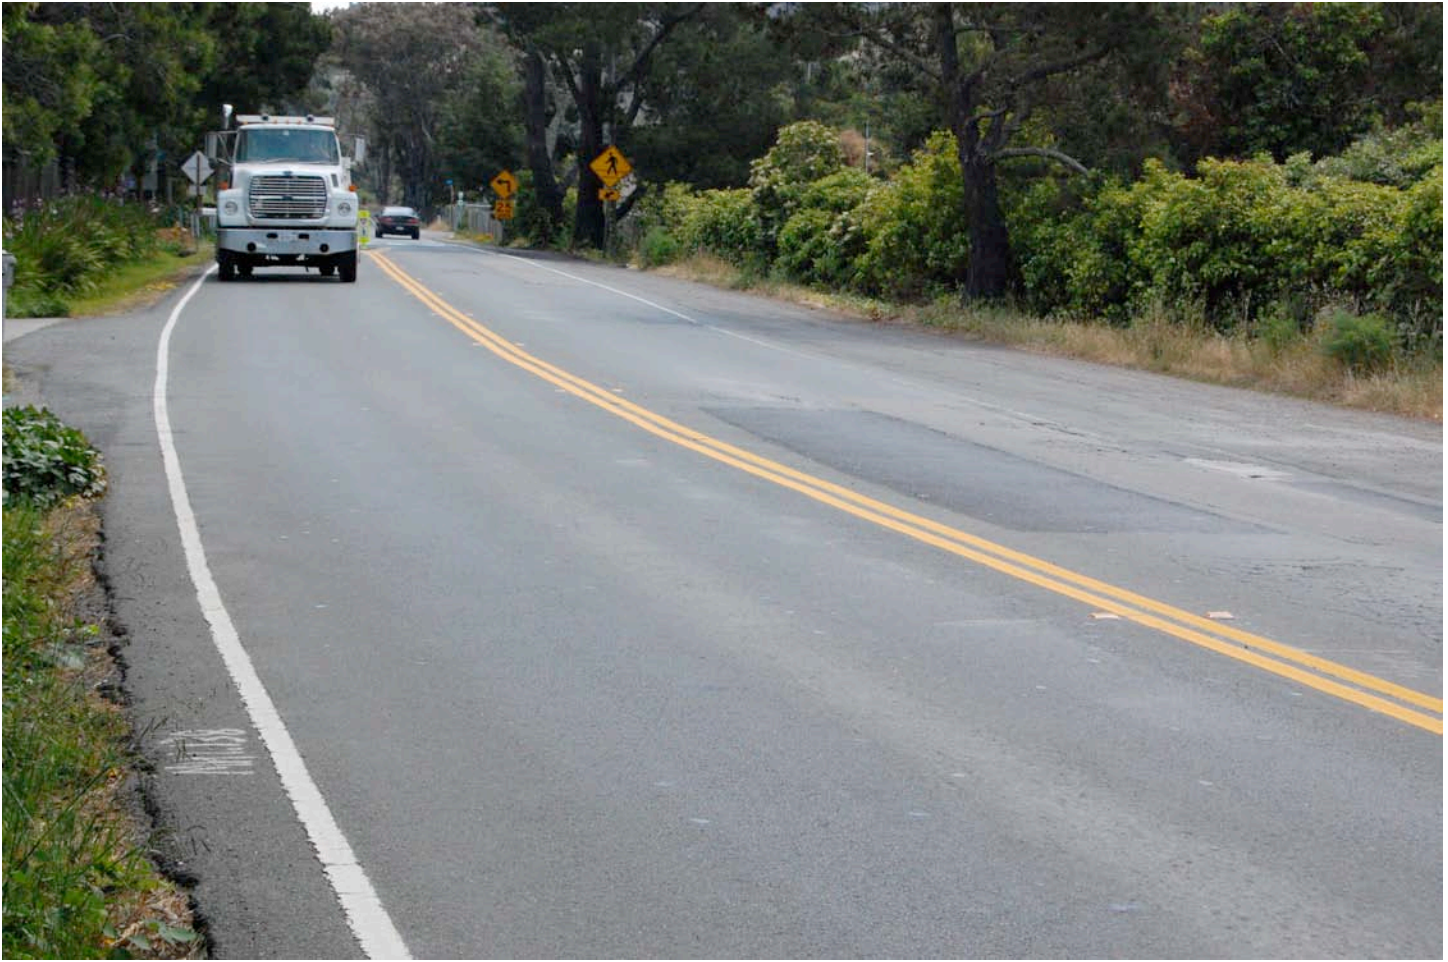
Eastbound view of Shoreline Highway at crash scene. Note how closely the truck in the photos is to the fog line. Additionally, note how narrow the shoulder is on the Westbound lane (with truck), and how much more shoulder there is for the Eastbound lane. The yellow centerline could be moved to provide more shoulder room in the westbound lane.

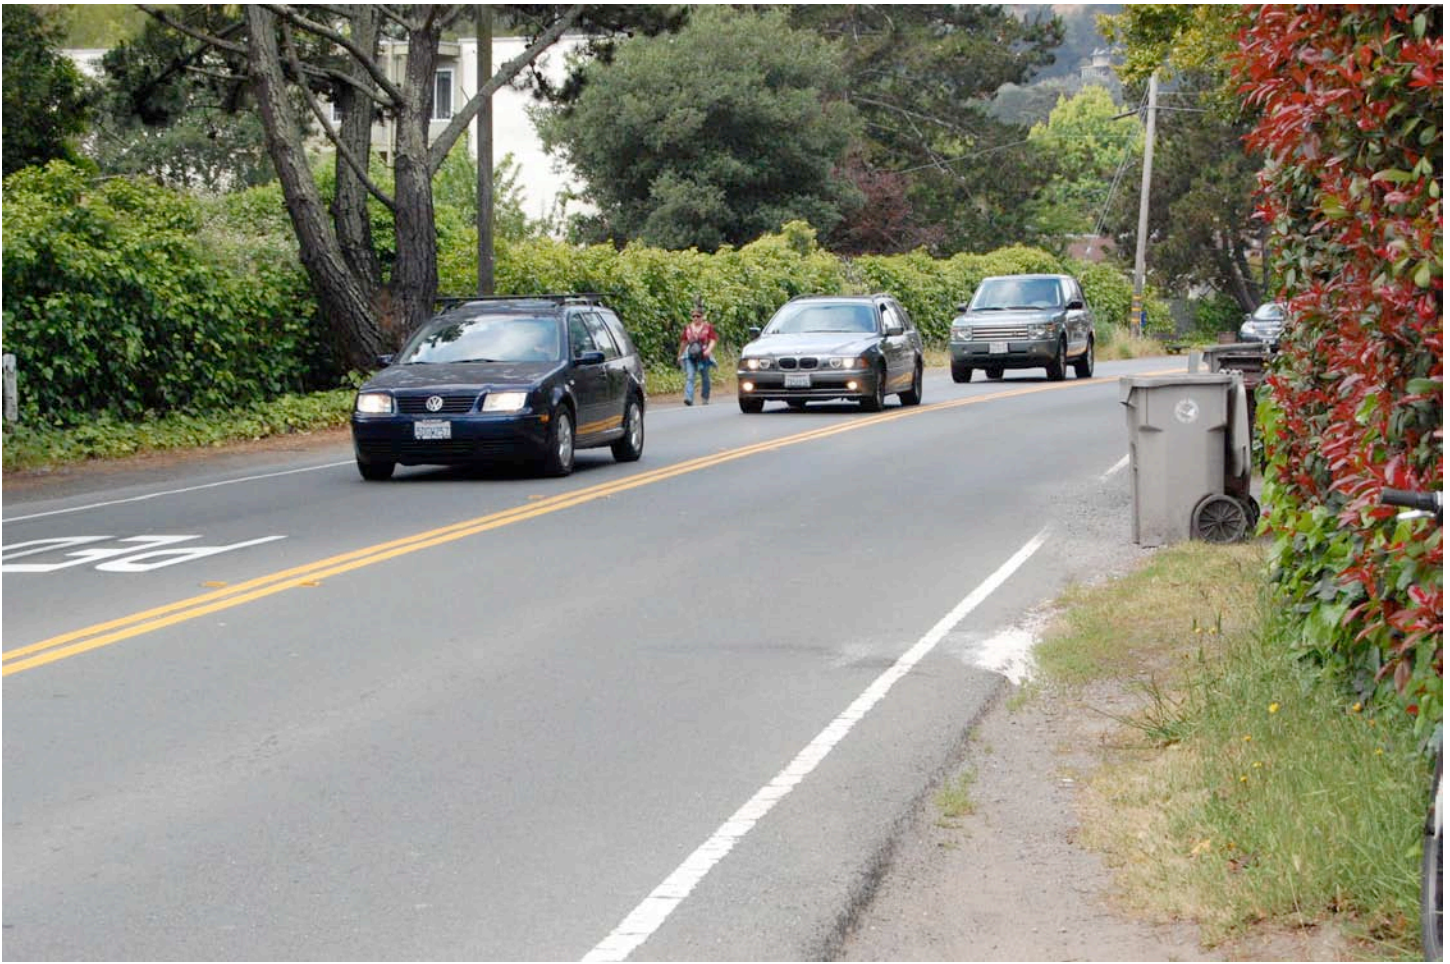
Pedestrians use Shoreline Highway as a main route out of the Tamalpais Valley. Here one is seen heading eastbound. On the right side of the picture the actual crash site can be seen, with the white absorbent material and pavement stains from injuries sustained by the bicyclist right at the fog line. Note how narrow and uneven the shoulder is at this location.

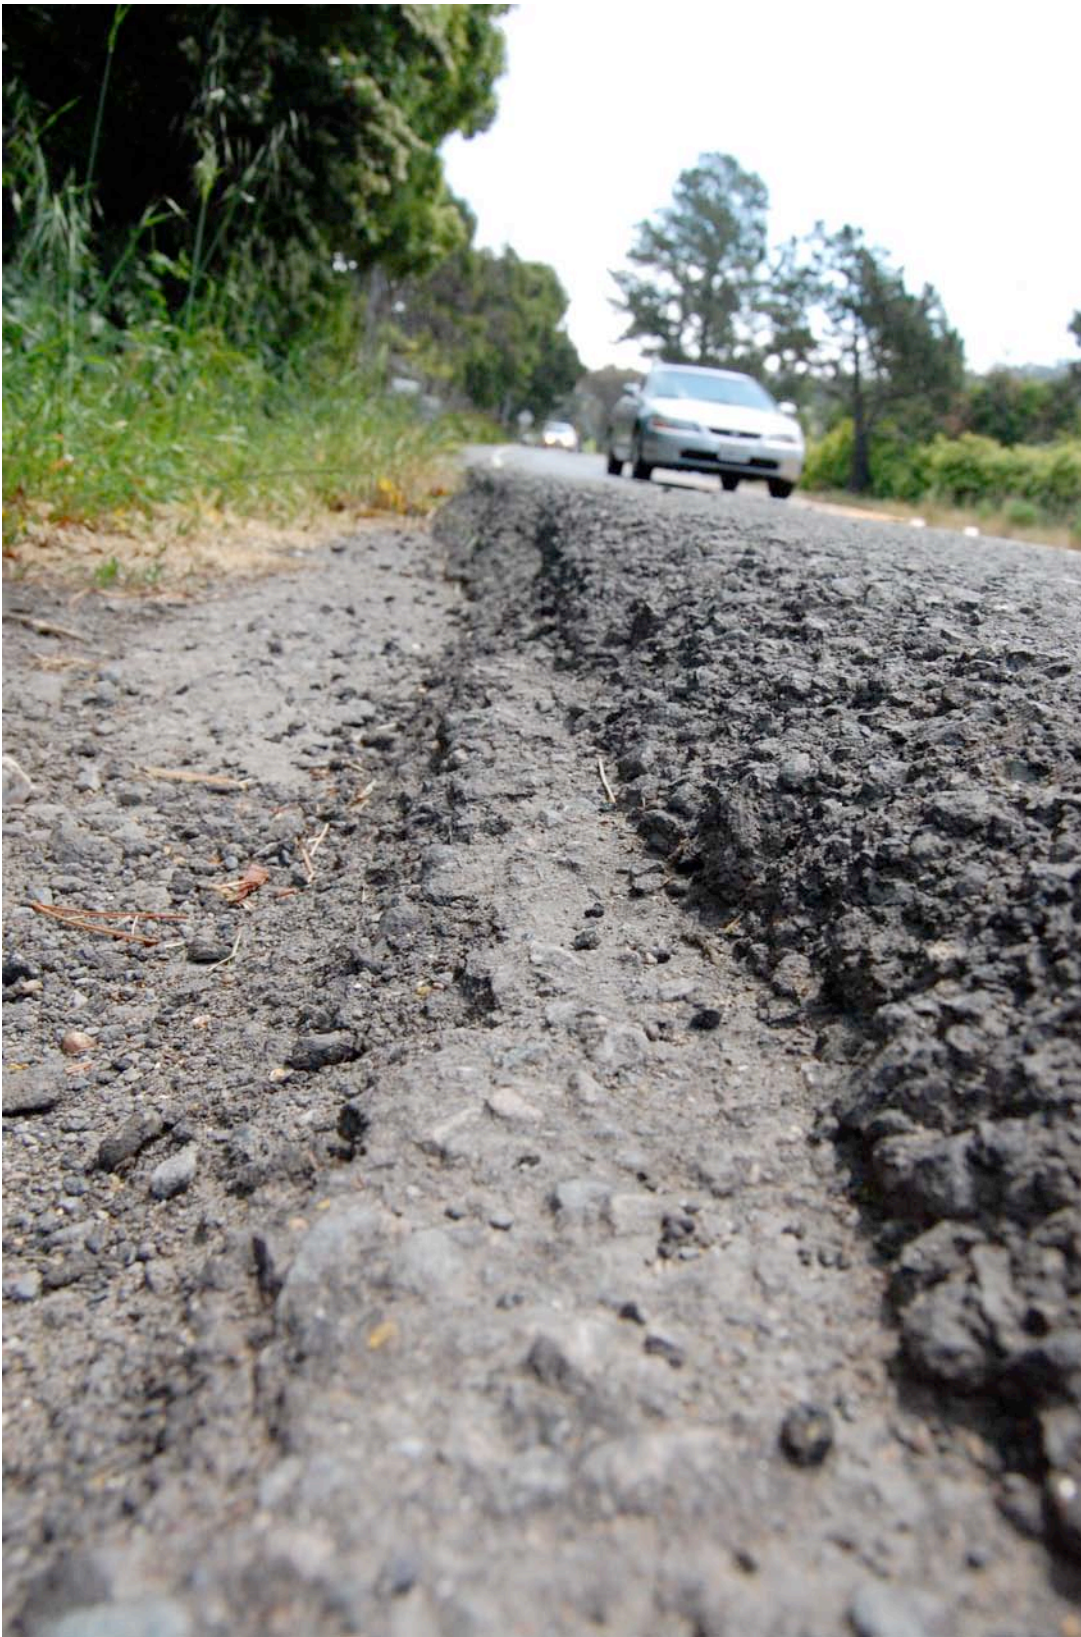
Edge of pavement at crash site. Three asphalt overlays can be seen. The fog line is faintly visible to the left of the car. Note the pavement steepness and degradation in conjunction with asphalt crumbling and forming loose gravel.
